# Javanese Limasan Architecture and 3D Modeling for the Revitalization of the Rumah Sandi Dukuh Heritage Site

| ABSTRACT | KEYWORDS |
|---|---|
| <p>Rumah Sandi Dukuh is a Javanese <i>limasan</i> house in Kulon Progo, Yogyakarta, that served as an emergency post of the Dinas Code, Indonesia's wartime cryptography service, during the Second Dutch Military Aggression, and is now managed by Museum Sandi as an object presumed to be cultural heritage. Its revitalization programme had not been preceded by a systematic architectural study, leaving the building's historical form undocumented ahead of physical intervention. This study documents the identity, dimensions, and architectural style of Rumah Sandi Dukuh and produces a three-dimensional model as a technical reference for its revitalization. A qualitative case study carried out between September and December 2024 combined field observation and architectural measurement at the site, in-depth interviews with the museum officer responsible for the site and with a son of the original owner, and a literature study on heritage revitalization and Javanese vernacular architecture. Building-identity data were compiled on a Cultural Heritag

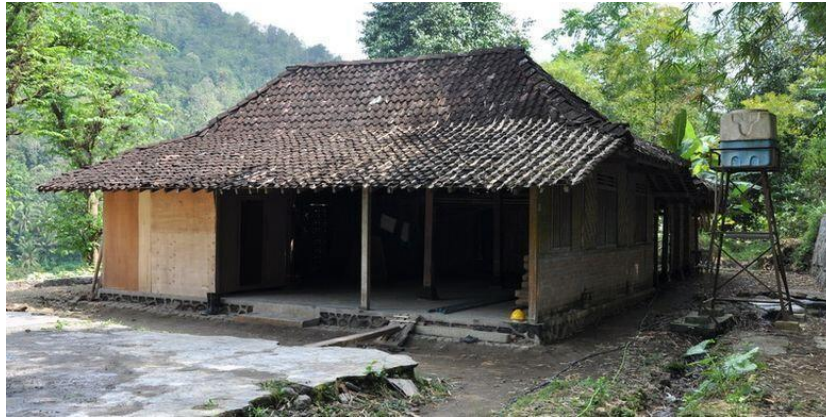
Figure 1. Rumah Sandi Dukuh prior to revitalization, exterior view

Combining the field measurements, the interview data, and the literature on *limasan* typology, this study classifies Rumah Sandi Dukuh as a *limasan apitan pengapit*, a subtype formed by joining two *limasan lawakan* units, each built around its own *ander*, at their *emper* (verandah) and fitted with a *talang air* (rain gutter) at the join (Wibowo et al., 1998, p. 48). This composite form is visible in the building's current, pre-revitalization condition (Figure 1), where the two roof volumes and their shared verandah line remain legible despite the deterioration of the structure's cladding and floor. The building's interior further shows the timber post-and-beam system characteristic of the *limasan*'s structural logic (Figure 2), with the *ander* and its supporting columns still standing and providing the principal reference points used for the subsequent 3D reconstruction.

The material inventory recorded on the building-identity sheet (Table 2) lists wood and bamboo as the primary structural materials, combined with stone, marble, and reinforced concrete, and this mixture is itself analytically informative rather than merely descriptive. Timber and bamboo are the materials of the building's original vernacular construction: the *saka*, *blandar*, *ander*, and *usuk* are all timber members, while bamboo appears in the woven wall panels (*gedhek*) visible in the interior documentation (Figure 2). Stone and reinforced concrete, by contrast, are almost certainly later additions; the concrete plinth and the partial masonry visible along the base of the exterior in Figure 1 are not features of a pre-1948 rural *limasan*,

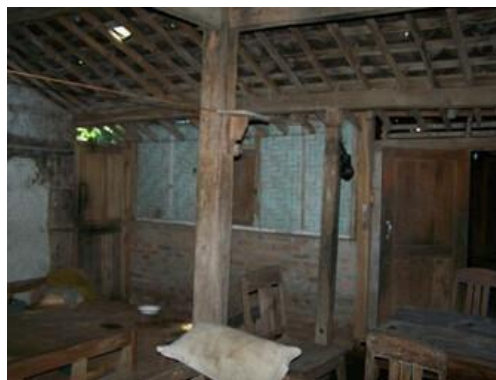
Figure 2. Interior structural elements of Rumah Sandi Dukuh, showing timber columns and roof framing  
Photograph by the author, Dusun Dukuh, Samigaluh, Kulon Progo, 24 September 2024. Reproduced by permission of Museum Sandi.

Beyond the *ander* itself, the *limasan* roof frame documented at the site follows the layered structural vocabulary described by Wibowo et al. (1998): a horizontal ring beam (*blandar*) carried on the main columns (*saka*), diagonal rafters (*usuk*) rising from the *blandar* to the ridge assembly, and a covering of clay roof tiles laid over a lath structure, with the paired-unit *apitan pengapit* form doubling this system across the shared *emper*. Measured against the building-identity data in Table 2, the roof's two distinct height points, 4.16 m at the front section and 4.58 m at the rear, correspond to the two joined *limasan latwakan* volumes rather than to a single unified roof plane, a detail that the field measurement made legible but that would not have been recoverable from oral testimony or archival photographs alone. Documenting this structural detail before revitalization began was necessary precisely because it is the kind of information that is difficult to reconstruct once cladding, flooring, or roofing members have been replaced.

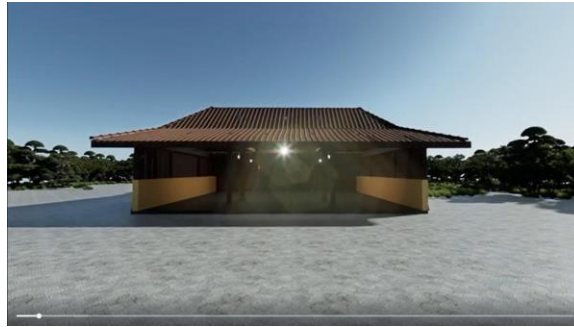
Figure 3. Three-dimensional model of Rumah Sandi Dukuh, exterior view  
Model by the Curator Assistant Division, Museum Sandi, 2024. Reproduced by permission of Museum Sandi.

division without dedicated surveying equipment could realistically carry out. Every element visible in the field observation, the interview data, and the literature study was translated into the model in detail, so that the building's original form could be represented as accurately as the available evidence allowed (Figures 3 and 4).

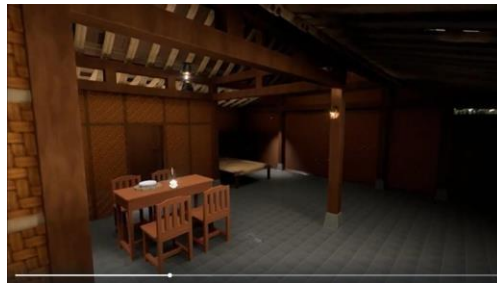
Figure 4. Three-dimensional model of Rumah Sandi Dukuh, interior view  
Model by the Curator Assistant Division, Museum Sandi, 2024. Reproduced by permission of Museum Sandi.
